This spreadsheet performs screening level calculations to estimate the effect of peeling leaded paint on the average concentration of lead in yard soil
3619 Lafayette Street

Property ID: 473	Date: 8-16-05
Address: 3619 LAFAYETTE ST	Telephone #:
Owner:	CO Certification #: 12860
Inspector/Assessor:

LBP Assessment Results

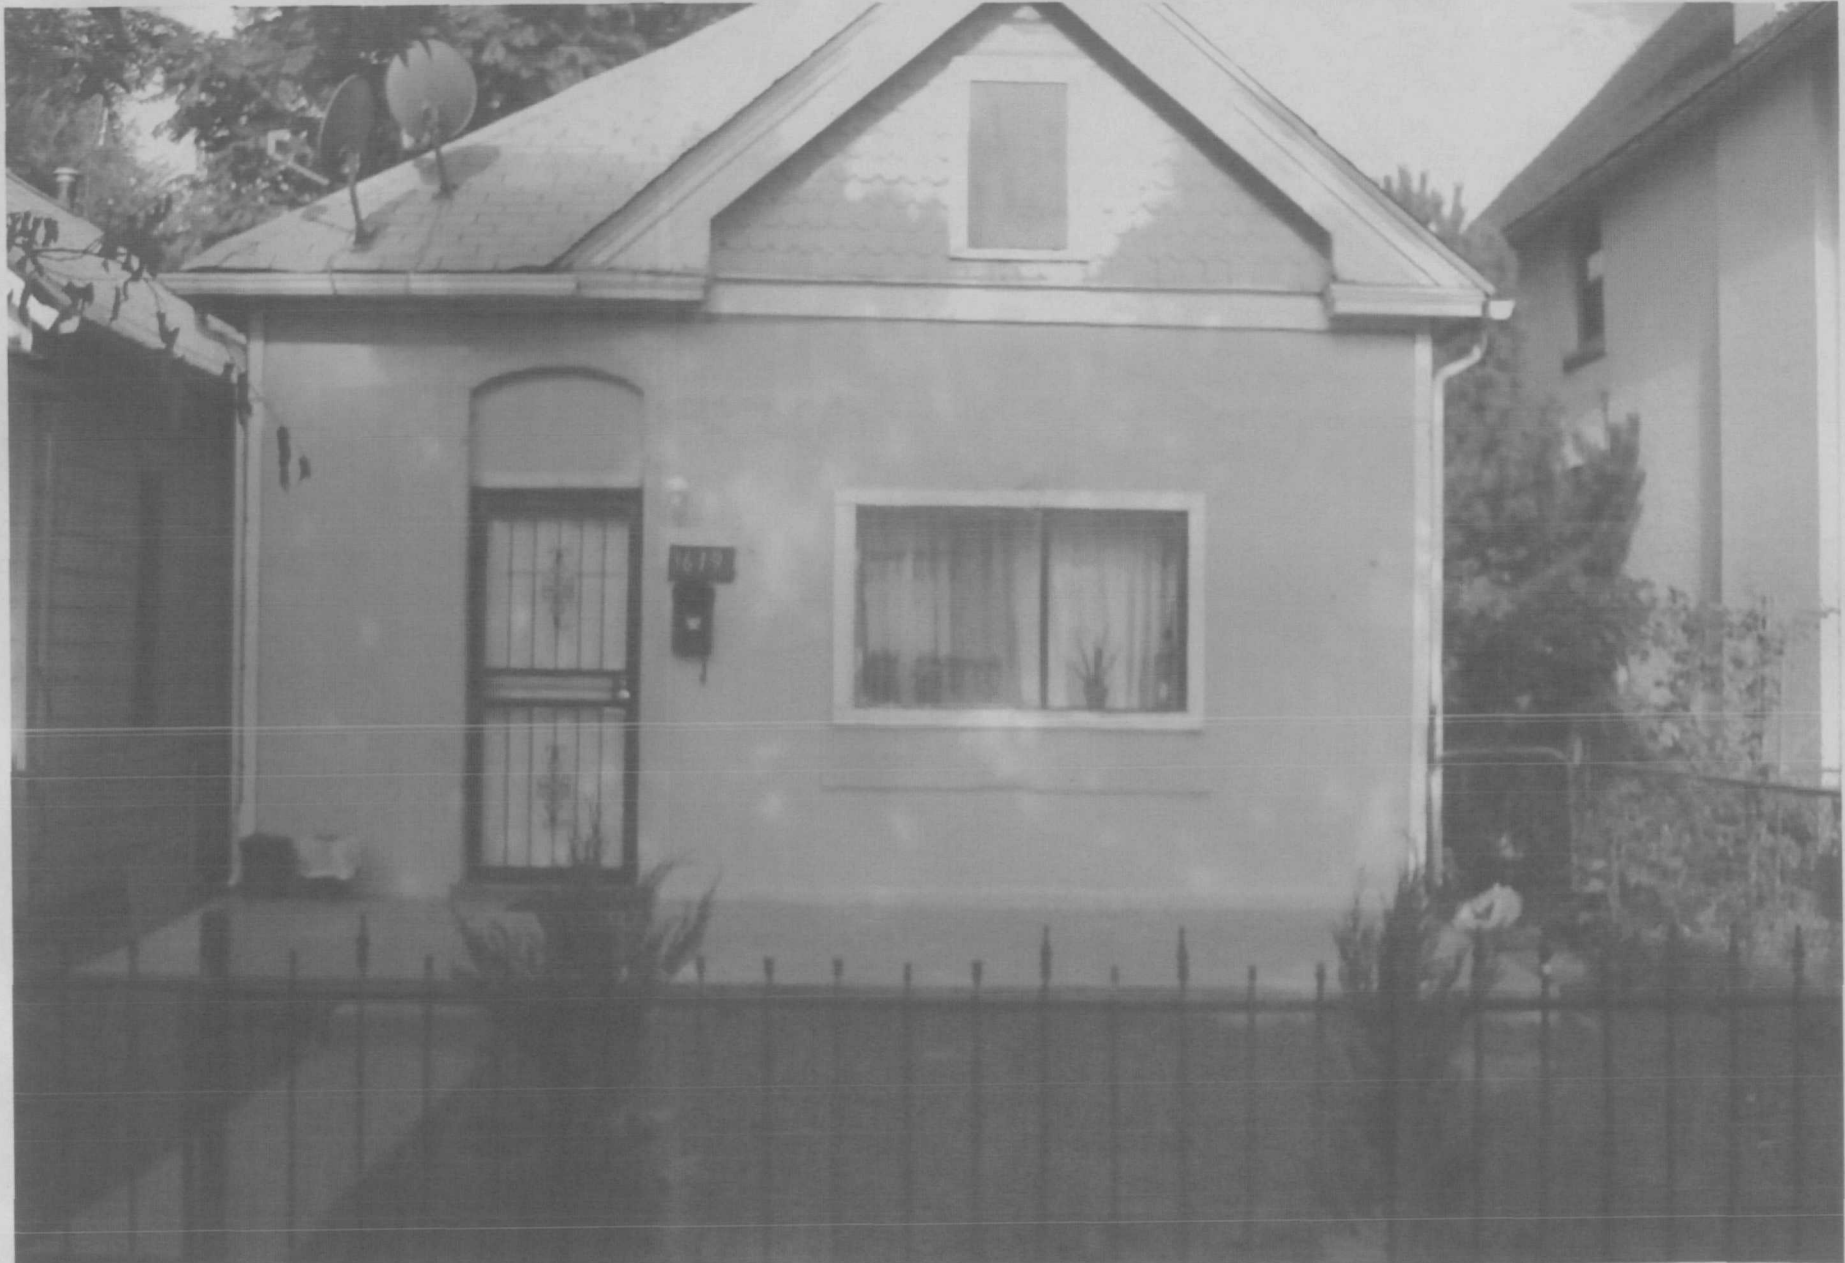
Property ID # 473 / 3619 Lafayette

Majority of house does not contain lead paint
